AFC-330

Automated Fundus Camera

Clinical Atlas

Retina Disease

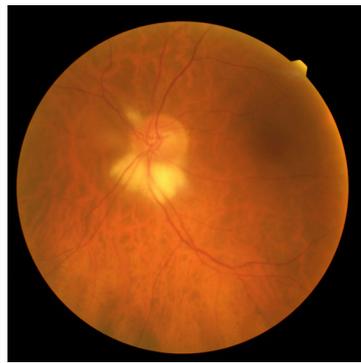
Myelinated-Nerves - A simple “birth mark.” This was the first time the patient could see what previous eye doctors told him concerning his eye.

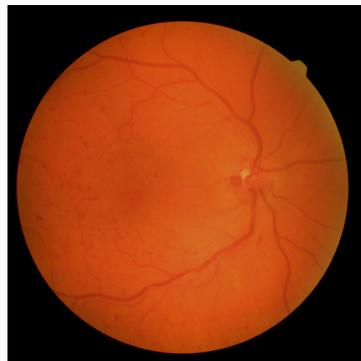
Central Vein Occlusion - Photo was taken undilated during routine pre-testing with an asymptomatic patient. The patient was dilated and the photos were re-taken after dilation. The photos were the same quality dilated and undilated (the patient had cataracts so the photos were not sharp). The patient was referred to a retinal specialist for injections to restore her vision.

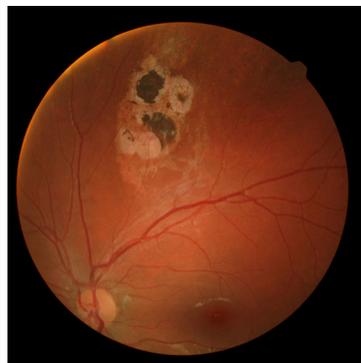
Commotio-Retinae - Bruising from blunt force trauma. This patient was kicked in the eye 10 years prior during a soccer event. Undilated photo.

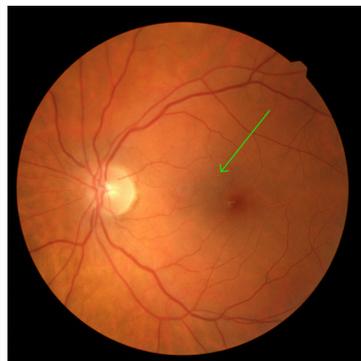
Hollenhorst-Plaque - A small piece of cholesterol that got stuck in one of the small retinal vessels. This was a pre-test photo (undilated). The cholesterol could not be found easily on the eye though it is obvious in the photo. On a routine dilated exam, it would have been missed looking at the patient’s retina. The camera found it. The patient was advised to get a cholesterol and neck artery (carotid) exam. If this happens in the brain (cholesterol emboli), this would be a stroke.

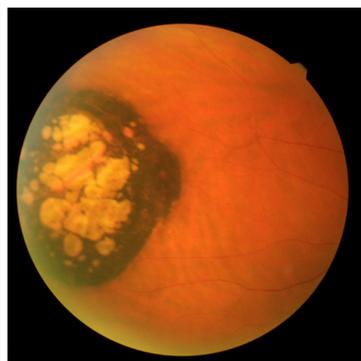
Retinal-Hole - The retinal defect was out in the periphery (next to the ora serrata), out beyond the standard-7 shot mode. After switching to the manual mode, this shot was easily taken. This was the first time the patient could see the retinal hole after being told about it for 15-20 years.

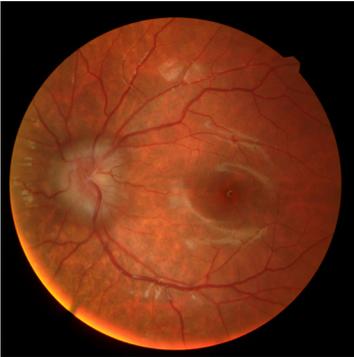
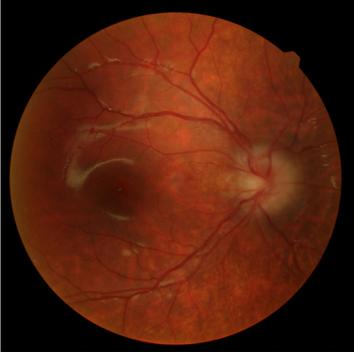
Pseudo Tumor Cerebri - Photos of a 13-year-old white female presented for a routine eyeglass exam. Notice the optic nerve head swelling. Diagnosed with pseudo tumor. This is a very strong example of how important it is to perform retinal exams.

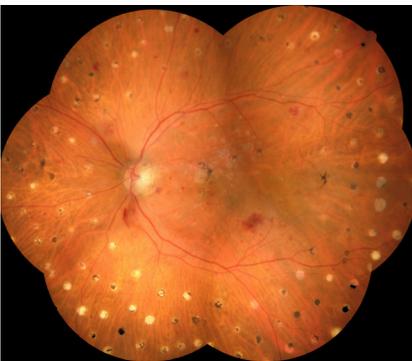
Diabetic-Laser-Surgery - An eye with very poor vision (20/100) taken by a tech recently graduated from high school. This would have been an extremely difficult photo to do with other cameras. The AFC-330 easily takes photos that were previously difficult to take, or needing highly trained/ specialized staff.

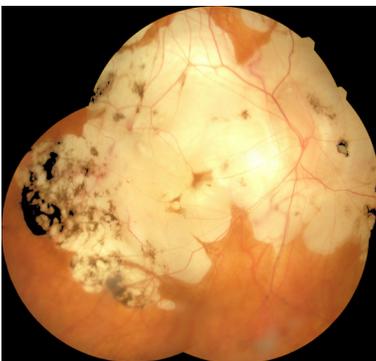
Coloboma - This is a Panoramic set acquired by the AFC-330 and auto-montaged with NAVIS-EX software: this displays a birth defect where a hole does not close. Effects to vision is dependent upon location of the hole. In this case the patient can fixate and it is located in the peripheral retina.

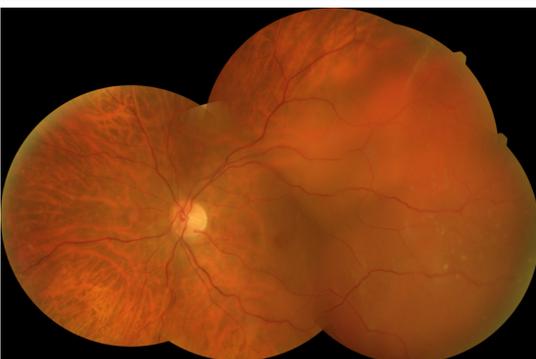
Retinal-Detachment - This patient was seen the day the detachment was in progress. The patient could see the detachment moving across, and her losing her vision as it happened. The patient was in surgery a couple hours after this photo. This photo was difficult to obtain because the patient had very little vision and could not focus on the camera target. The AFC was set to manual mode to get these shots.

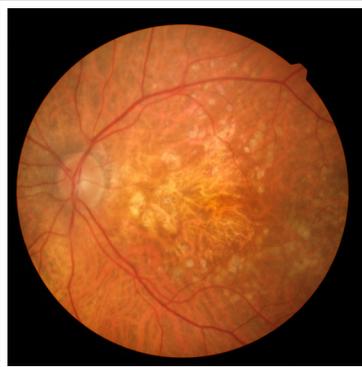
Dry-Macular-Degeneration - This was a pre-test photo on an undilated eye from a new patient referred from a retinal specialist for a low vision evaluation. The patient was recently dilated and the pre-test photo was clear to where the patient did not need to be dilated again. Nothing more could be done with her glasses or magnifiers but her family with her got to see why she could no longer see. It was the first time they saw what was going on in her eye.

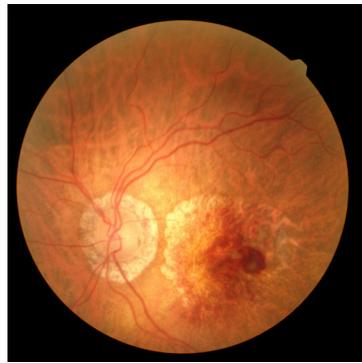
Wet AMD - Wet age-related macular degeneration. This is a pre-test photo on an undilated eye. The patient had seen the retinal specialist with dilation a week earlier.

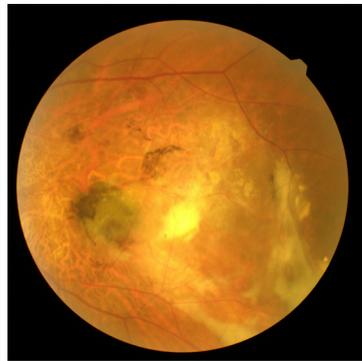
Disciform-Scarring - The end stage of wet macular degeneration. These photos shown to the patient and family conveyed the reason to why you “just can’t make their glasses stronger” to see better. It is a good tool for patients to come to understand the reality of their vision and bring closure to it.

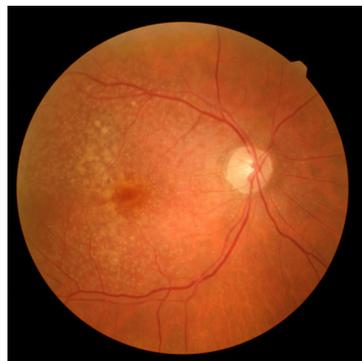
Drusen - This is a single 45 degree photo automatically acquired with the AFC-330: Drusen are yellow or white build ups of extracellular material in the retinal layers. It is normal to have presence of drusen as we age, but large amounts can indicate signs of age-related macular degeneration (AMD).

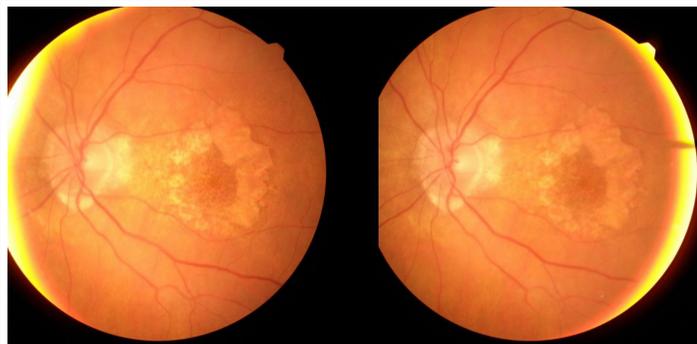
Stereo-Macula - Viewing with a stereo viewer. The AFC camera has the ability to take full 45 degree photos of the retina twice (separated by 3 degrees). When doing the stereo composition you can use the “zoom out function” to get back to the full view of the retina (instead of zoomed in on the ONH) and voila! You can get an entire retina in stereo. When you look at this photo in stereo full-screen, you can see the retina surrounding the macula is gone. There is just a central island of retina left. “Stereo macula” shots can also be used to see if there is any elevation (like a choroidal nevus).

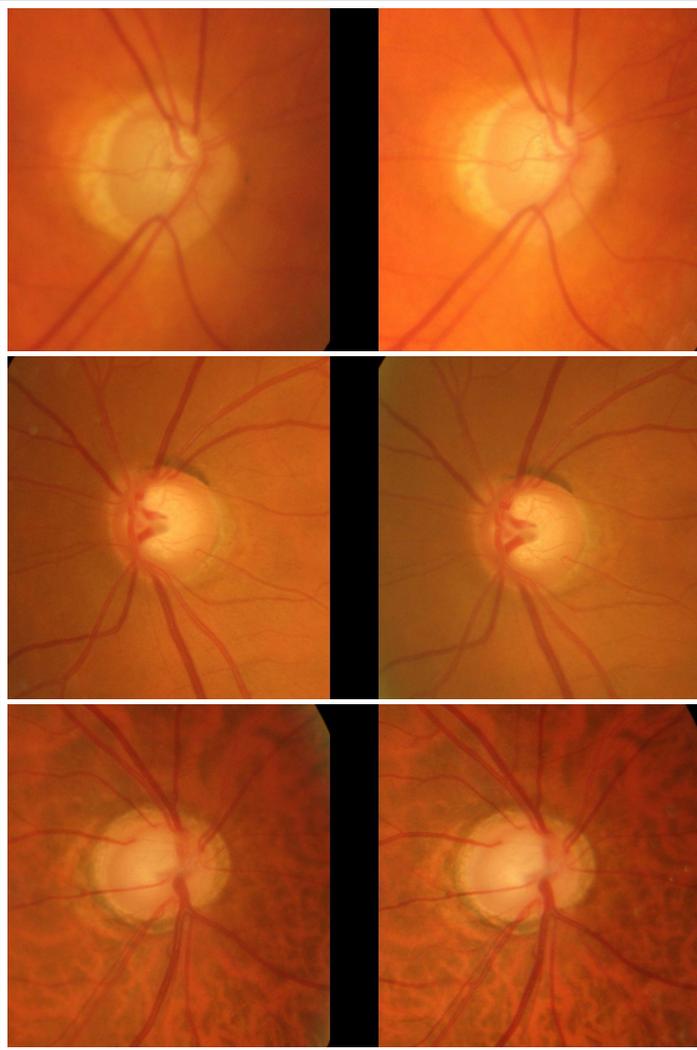
Glaucoma - The ability to obtain so many stereo optic nerve head (ONH) shots and see these on a large 22 inch computer at full screen can change your diagnosis and treatment plan for patients. To be able to set and focus on the ONH on-screen (instead of with an uncomfortable bright light slit lamp light) is invaluable. You can really see what is going on with the nerve - really a game changer. The stereo photos are also incredibly easy to get.

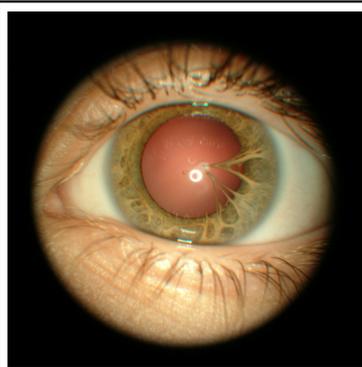
Congenital Cataract - Routine photos can be taken (internal nonmydriatic and external) on all patients during pre-testing since the AFC-330 is so quick and easy to use. Especially since it has the ability to interface with OfficeMate software. There is no need to manually re-input patient demographics into Navis or the AFC. This is just one of the everyday photos taken during a routine pre-test.

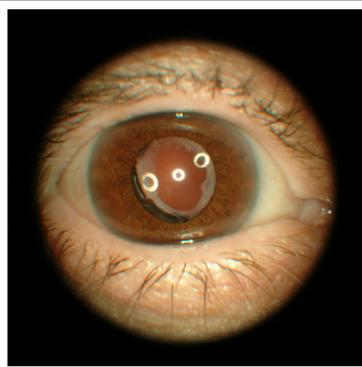
Intraocular-Lens - A patient returned after cataract surgery. She had extraordinarily large pupils (this photo was undilated) and she was shown her new lens put inside her eye. It was her "ah-ha" moment. She realized what cataract surgery was. She was unable to understand the concept of cataract surgery from the explanations by the physician, the surgeon, or techs, but she was able to understand the photo.

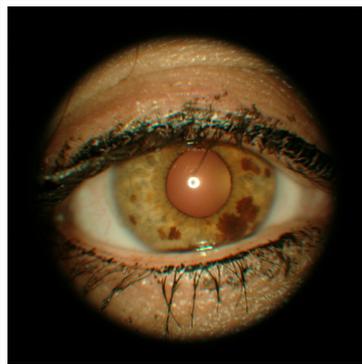
Iris-Nevus - A routine pre-test photo. It is quick and easy with the AFC to document any changes in a patient's iris nevus (freckles) over time.

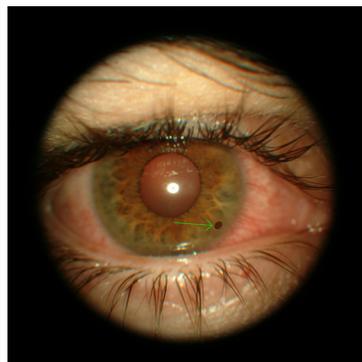
Corneal Foreign-Body - This photo was taken by a tech during the routine pre-test for a patient who had a foreign-body sensation. The physician saw the photo and was ready with an Algar Brush to remove the foreign object when it was time to see the patient. This is good legal-medical documentation of an external condition with a "retinal camera."

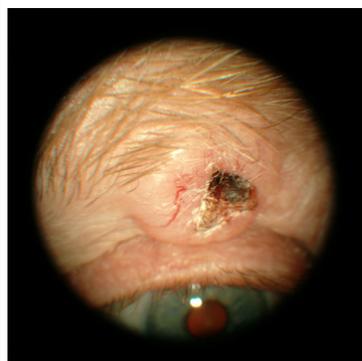
Basal-Cell-Carcinoma - This eyelid cancer was confirmed via a biopsy by dermatology. This is one of those conditions you want documentation to compare to at the next exam and after excision.

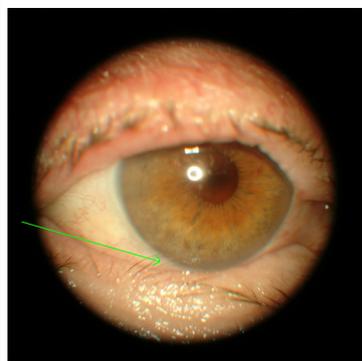
Trichiasis - Anterior Photo acquired by the AFC-330: note the eye lashes growing abnormally back towards the eye. This can cause corneal scarring and potential vision loss if untreated.

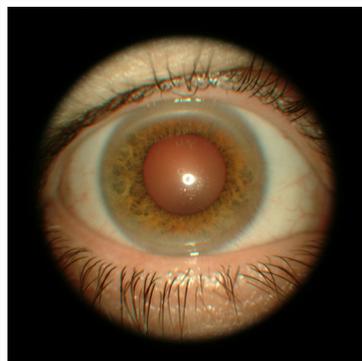
Arcus Senilis - Anterior Photo acquired by the AFC-330: note the white ring visible in the peripheral cornea. The ring is related to high cholesterol.

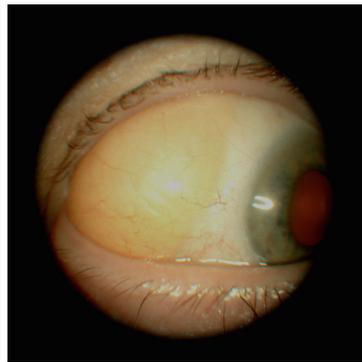
Conjunctival Cyst - Anterior Photo taken by the AFC-330: This is a fluid filled mass within the conjunctiva. Symptoms are discomfort and excessive tearing.
